Site C Backgrounder for Peter Kent

All Dams are Not Created Equal - Unstable Geology of the Peace Valley:

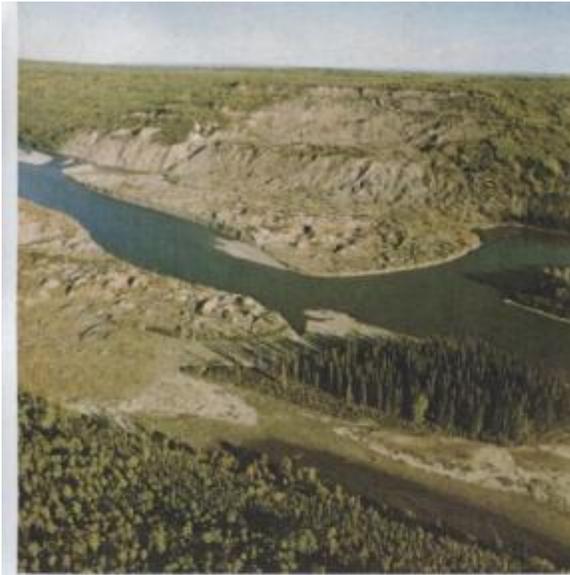
PHOTO 6-7. Looking southward across the Peace River at the Attachie landslide (Mile 63). The slide occurred on 26 May 1973 and its debris blocked the river for approximately 10 hours. It illustrates a rotational slide in overburden overlying shale bedrock.

The Attachie slide involved the slump of a huge amount of sediment, just a fraction of which entered the river. Had a reservoir been in place at full pool, a much greater portion of this 24 million cubic meters of sediment would have been trapped within the reservoir.

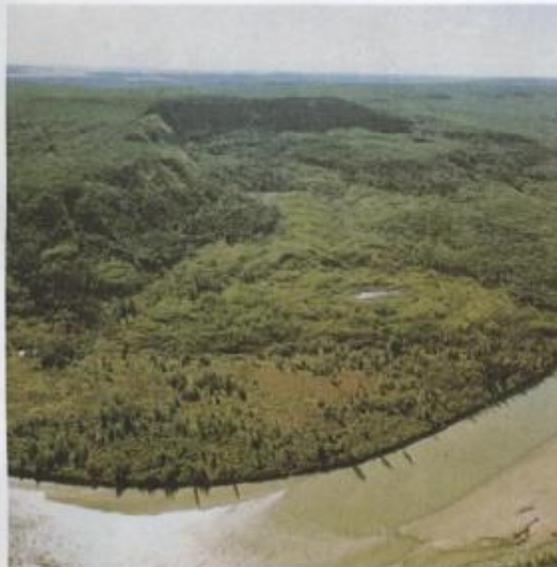
PHOTO 6-8. Looking southward over the Pine River toward a large slide in bedrock approximately one mile across. The slide occurred in shale of the Shaftesbury Formation. A similar slide 1.5 miles across and 1500 feet high occurred on the north bank of the Peace River downstream of Cache Creek.

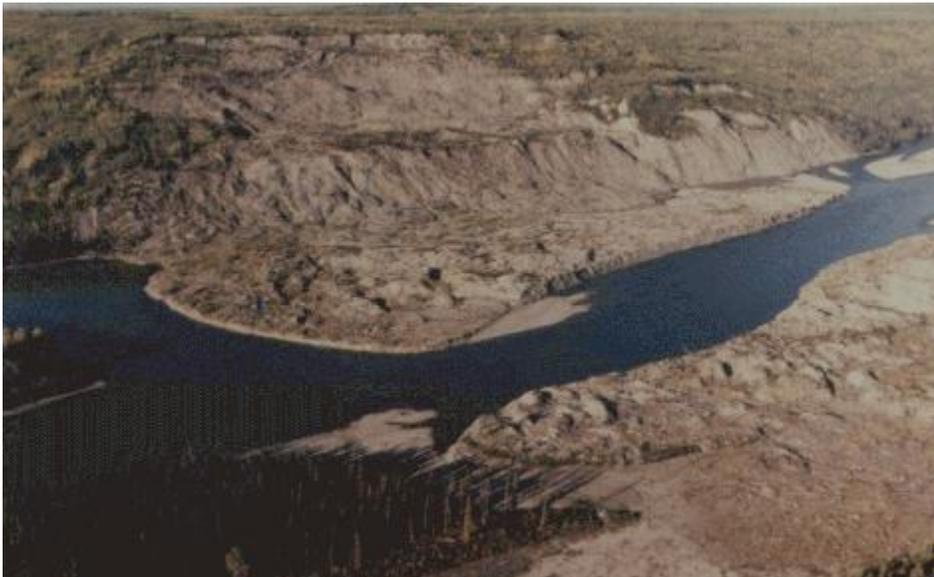
The Attachie slide of May 26, 1973 west of Fort St. John dammed the Peace River for approximately 10 hours (photo courtesy of Thurber Engineering Ltd.)

[the Attachie slide] suddenly developed into an extremely rapid flow slide of 6.4 Mm³[million cubic meters], damming a large river in the course of a few minutes and projecting a wave onto the opposite bank. The flow slide followed a period of strong infiltration.

Then, on 26 May 1973, a major flow slide was triggered (Evans et al. 1996). More than 50% of the total volume of the failing mass started moving suddenly and formed a flow slide of 6.4 Mm³ which descended a 50 m bedrock scarp and travelled nearly 1 km to its distal limit on the opposite side of the Peace River floodplain (Fig. 6). The debris generated a displacement wave that downed trees on the opposite bank and blocked the flow of the Peace River for about 10 h (Evans et al. 1996). Local inhabitants reported that noises generated by the slide lasted over a period of only 10 min (Thurber Consultants Ltd. 1973). This type of extremely rapid flow slide failure is not the usual mode of movement in insensitive, overconsolidated glaciolacustrine sediments.

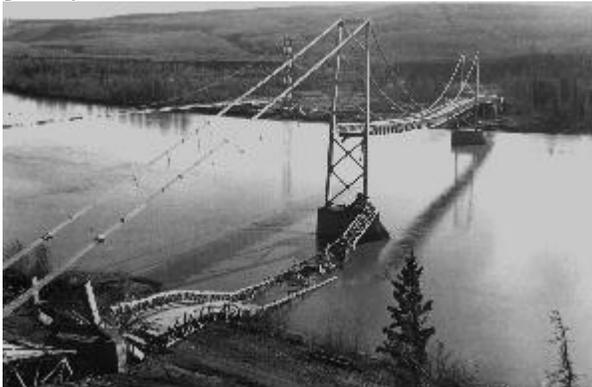
*The landslide was in Cretaceous shale....
 Geologists call this shale the Shaftesbury Formation....
 However, these rocks are very weak and quickly turn back into mud when they are near the surface and when they are exposed to water.*

Later investigations found that the bridge failed due to a landslide in the shale bedrock beneath the bridge. A landslide is the down-slope movement of rock or sediment under the influence of gravity. The landslide was about 330 metres wide and extended some 35 metres off shore.

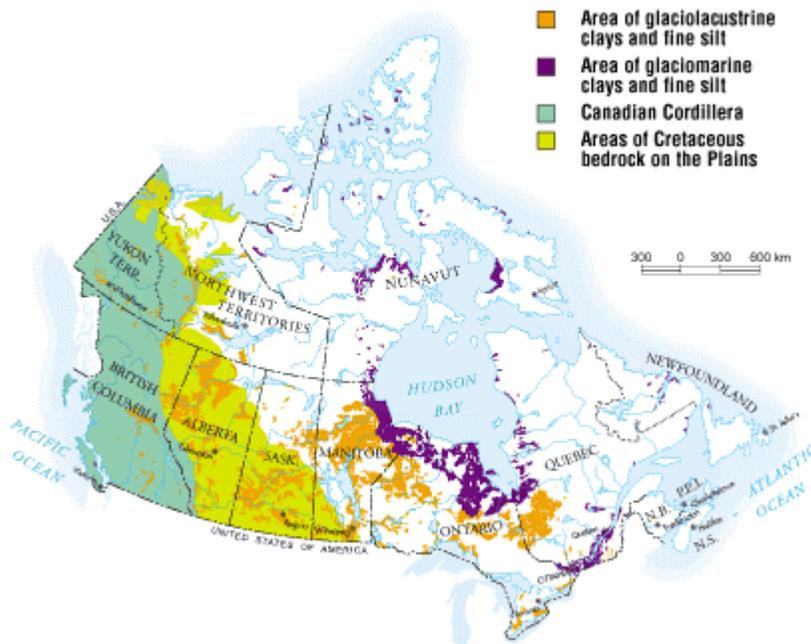
Valley slopes in the Peace River region are susceptible to landslides because of the nature of the rocks and sediments that are found in the area. Building in the valleys can make this situation worse. It is now believed that deterioration of the stability at the site of the Peace River bridge likely began soon after the bridge was first constructed and continued for a number of years afterwards. However, the final trigger for the landslide was probably high precipitation.

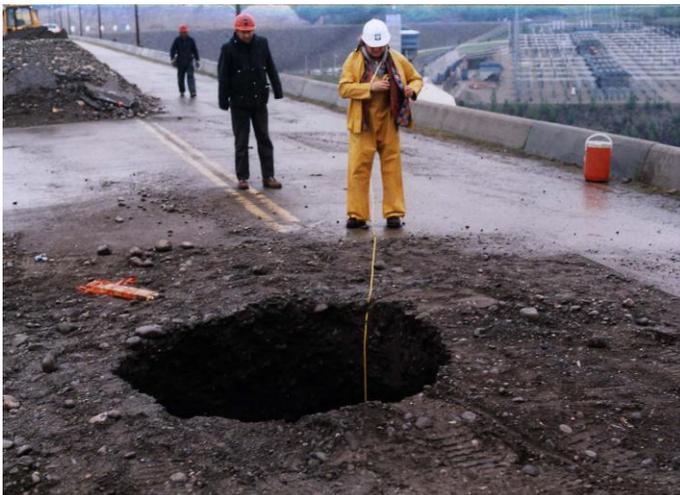
- 2.5 m diameter at crest
- 7 m deep sinkhole
- extremely loose zone to 80 m depth
- variable zone to 125 m depth
- Conventional instrumentation can detect internal erosion
- Conventional instrumentation can accelerate internal erosion

The Williston Reservoir level was ordered lowered last summer as a precaution after two sinkholes were discovered at the dam. A subsequent investigation found that internal erosion, specifically soil particle movement within the dam core, had occurred. Reduced capacity in the drainage system was also discovered.
