# Site C Dam Risks: Technical Backgrounder

Prepared by the Peace Valley Environment Association

## All Dams are Not Created Equal - Unstable Geology of the Peace Valley:

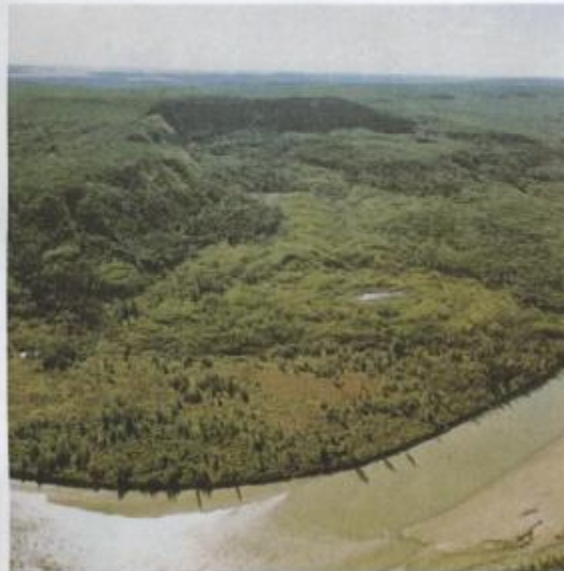
PHOTO 6-8. Looking southward over the Pine River toward a large slide in bedrock approximately one mile across. The slide occurred in shale of the Shaftesbury Formation. A similar slide 1.5 miles across and 1500 feet high occurred on the north bank of the Peace River downstream of Cache Creek.

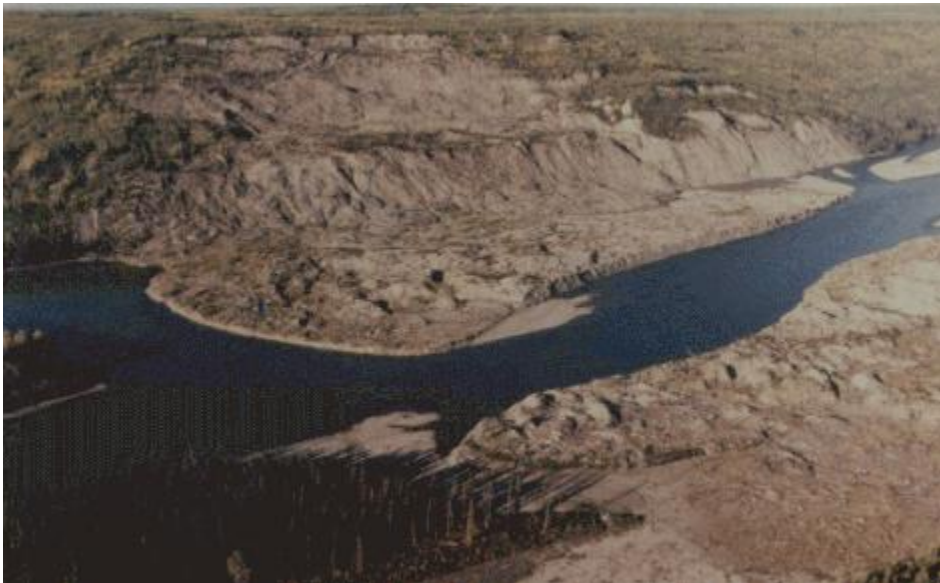
*1973 Attachie Slide/Fort St. John Clay slump  
Over 24 million cubic metres of sediment*

*The Attachie slide of May 26, 1973 west of Fort St. John dammed the Peace River for approximately 10 hours (photo courtesy of Thurber Engineering Ltd.)*

*[The Attachie slide] suddenly developed into an extremely rapid flow slide of 6.4 Mm<sup>3</sup>[million cubic meters], damming a large river in the course of a few minutes and projecting a wave onto the opposite bank. The flow slide followed a period of strong infiltration.*

*Then, on 26 May 1973, a major flow slide was triggered (Evans et al. 1996). More than 50% of the total volume of the failing mass started moving suddenly and formed a flow slide of 6.4 Mm<sup>3</sup> which descended a 50 m bedrock scarp and travelled nearly 1 km to its distal limit on the opposite side of the Peace River floodplain (Fig. 6). The debris generated a displacement wave that downed trees on the opposite bank and blocked the flow of the Peace River for about 10 h (Evans et al. 1996). Local inhabitants reported that noises generated by the slide lasted over a period of only 10 min (Thurber Consultants Ltd. 1973). This type of extremely rapid flow slide failure is not the usual mode of movement in insensitive, overconsolidated glaciolacustrine sediments.*

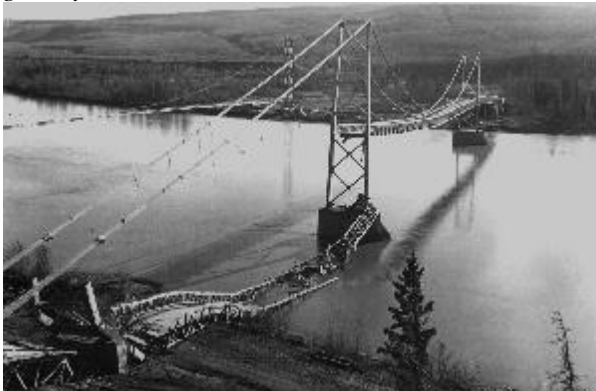
*Later investigations found that the bridge failed due to a landslide in the shale bedrock beneath the bridge. A landslide is the down-slope movement of rock or sediment under the influence of gravity. The landslide was about 330 metres wide and extended some 35 metres off shore.*

*The landslide was in Cretaceous shale....  
Geologists call this shale the Shaftesbury Formation....  
However, these rocks are very weak and quickly turn back into mud when they are near the surface and when they are exposed to water.*

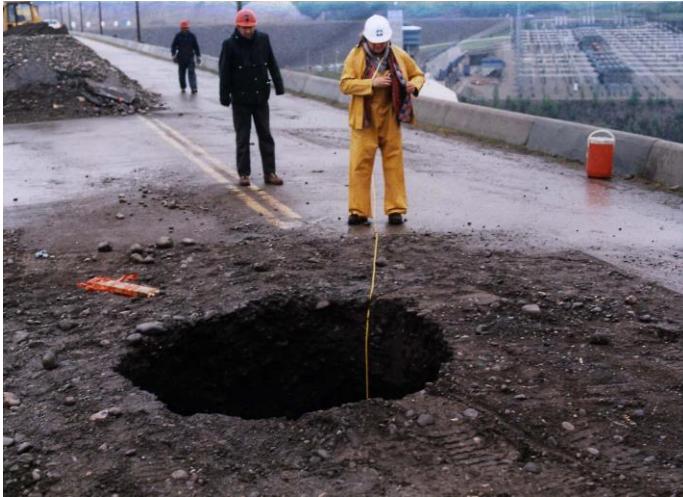
- 2.5 m diameter at crest
- 7 m deep sinkhole
- extremely loose zone to 80 m depth
- variable zone to 125 m depth

- Conventional instrumentation can detect internal erosion
- Conventional instrumentation can accelerate internal erosion
